A fire resistance test performed on a specimen of a fire retardant aluminium composite panel non load bearing partition wall to ASTM E119-12

334186

Objective To evaluate the fire resistance performance of a specimen of non-loadbearing partition when subjected to a test given in ASTM E119-12.

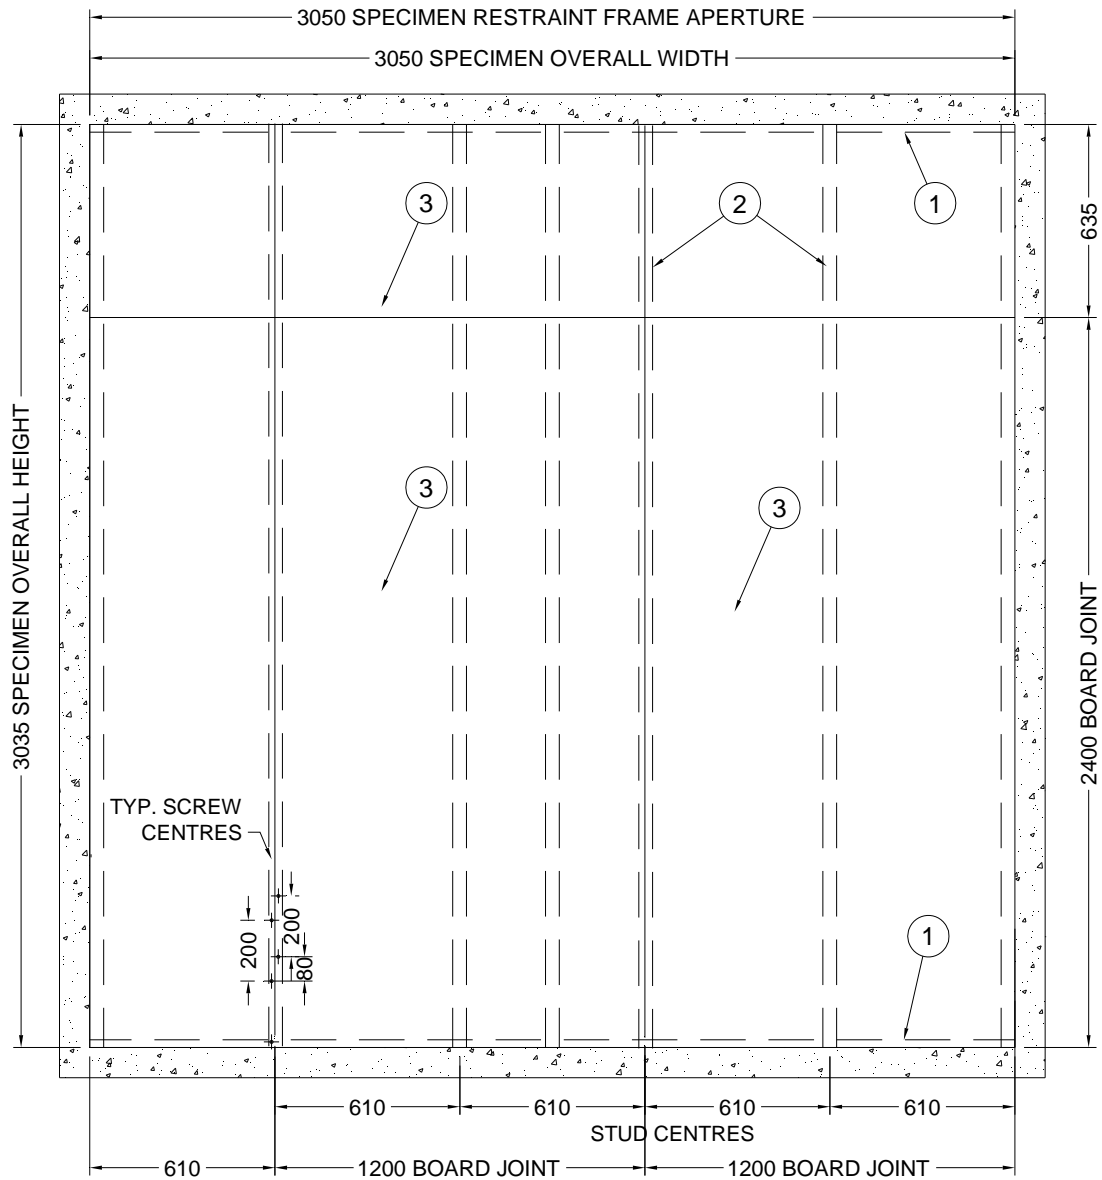
Figure 1- General elevation of test specimen and unexposed face thermocouples

- POSITIONS OF UNEXPOSED FACE THERMOCOUPLES.
- ALUMINUM PANELS AND TC POSITIONS OMITTED FOR CLARITY

(Refer to Figures 1 and 2)
 (All values are nominal unless stated otherwise)
 (All other details are as stated by the sponsor)

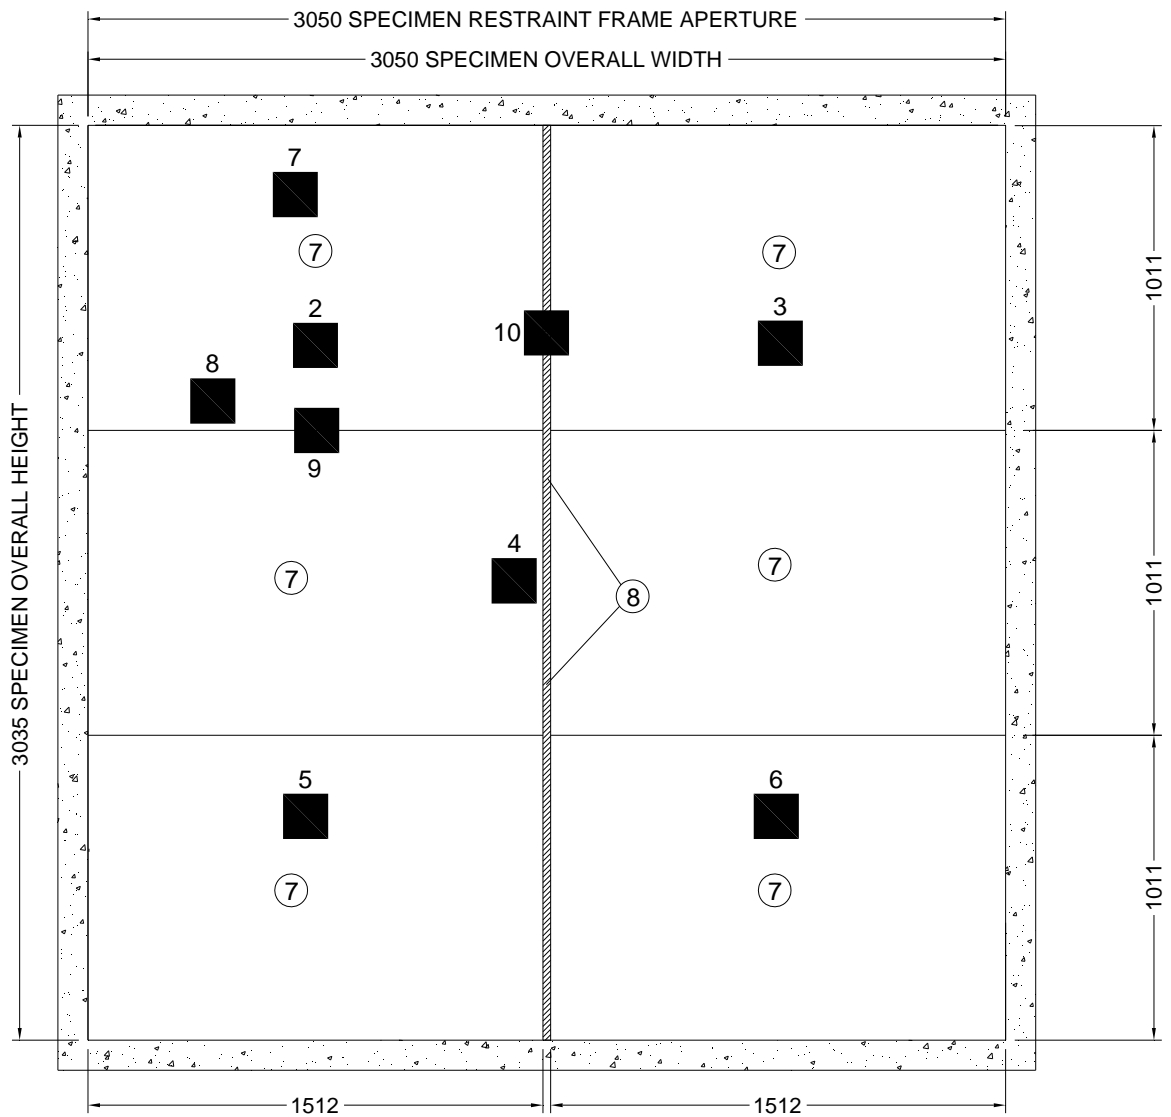
Figure 2 – General elevation of test specimen and unexposed face thermocouples

- POSITIONS OF UNEXPOSED FACE THERMOCOUPLES.
- HEAD/BASE CHANNELS, VERTICAL STUDS AND BOARDS

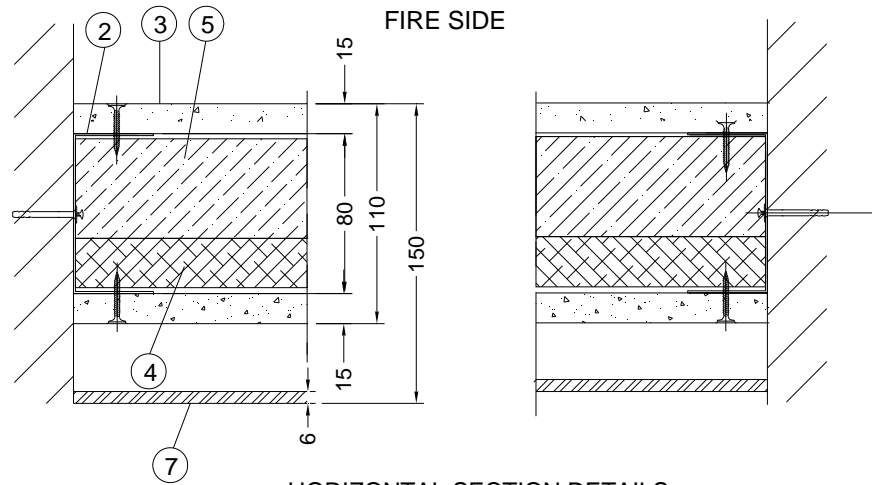
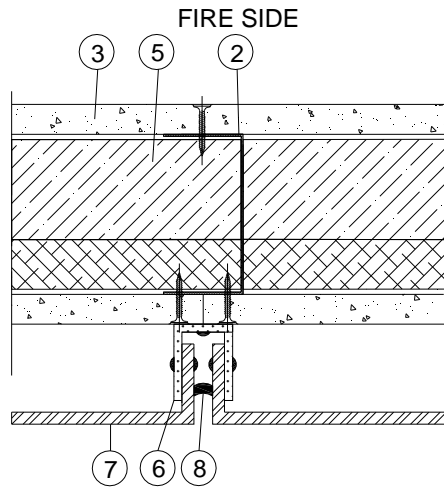
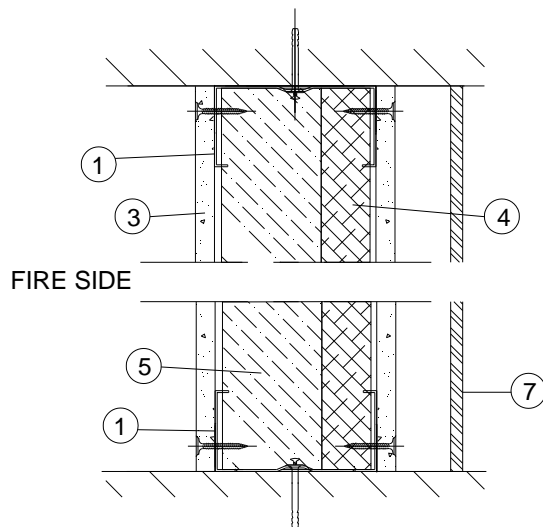
Figure 3 – Typical details of test specimen

HORIZONTAL SECTION DETAILS

HORIZONTAL SECTION AT A PANEL JOINT

VERTICAL SECTION DETAILS

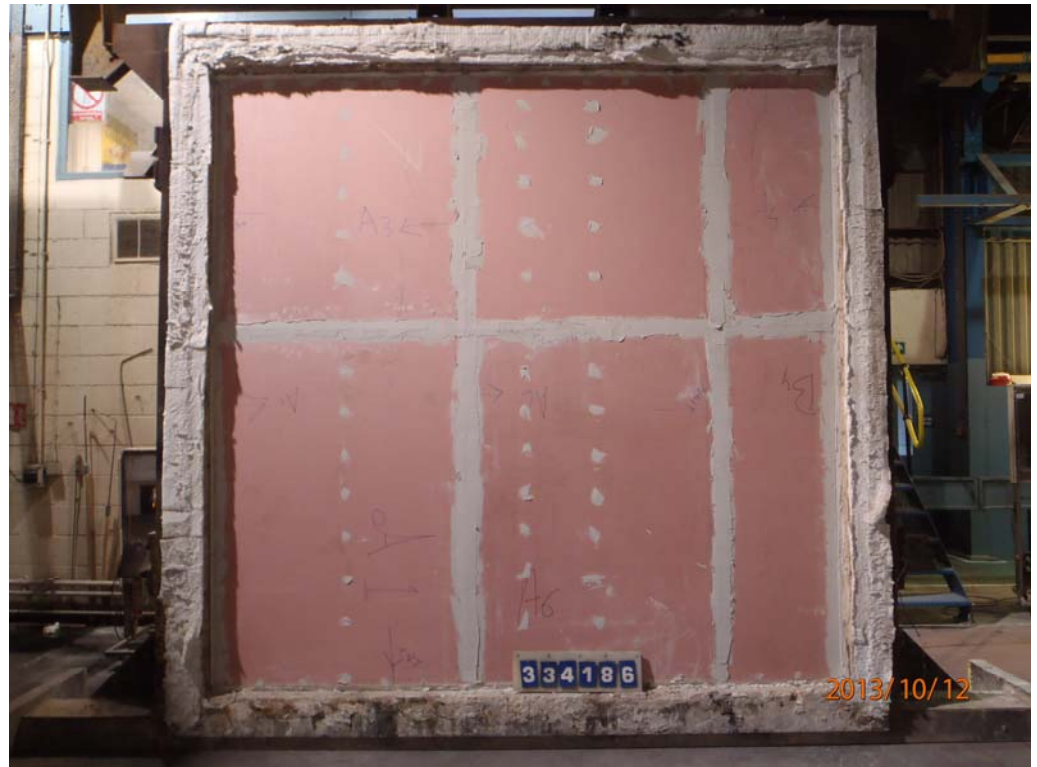
The exposed face of the specimen prior to testing

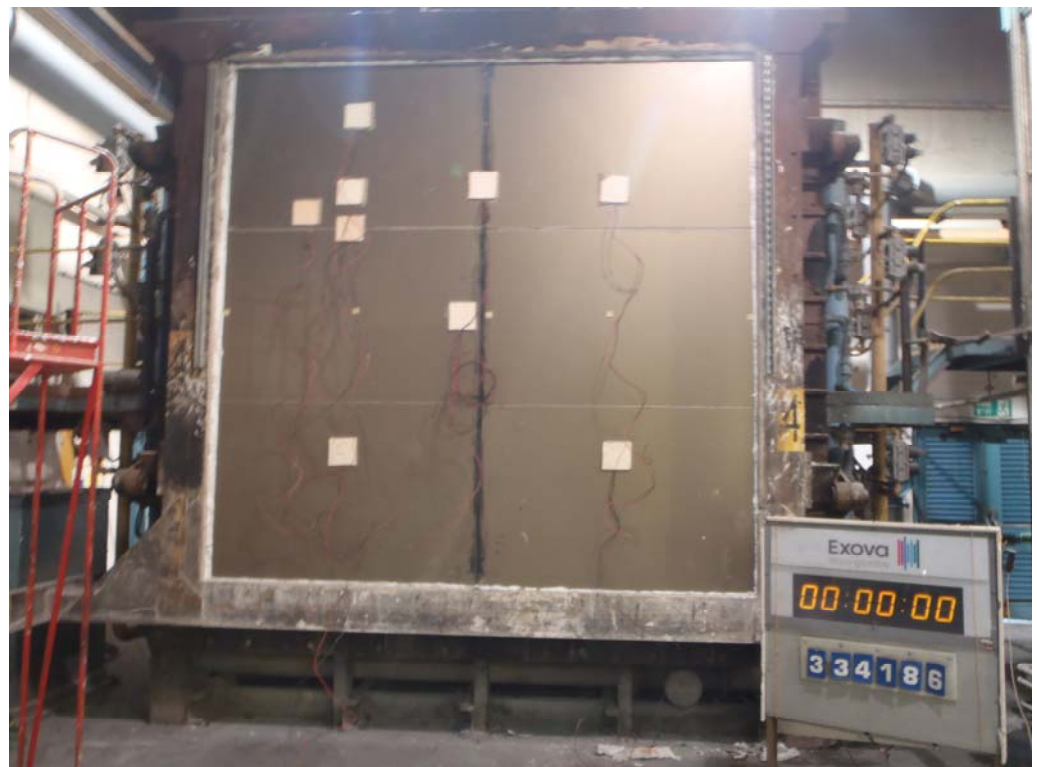
The unexposed face of the specimen prior to testing

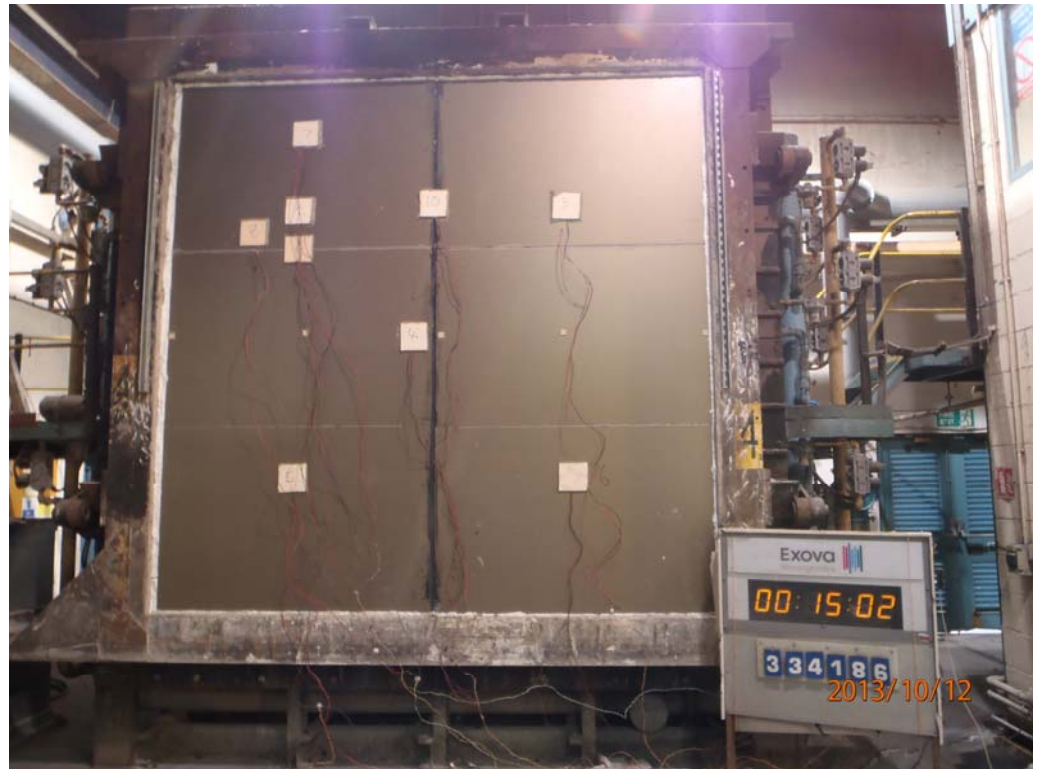
The unexposed face of the specimen after 15 minutes of testing

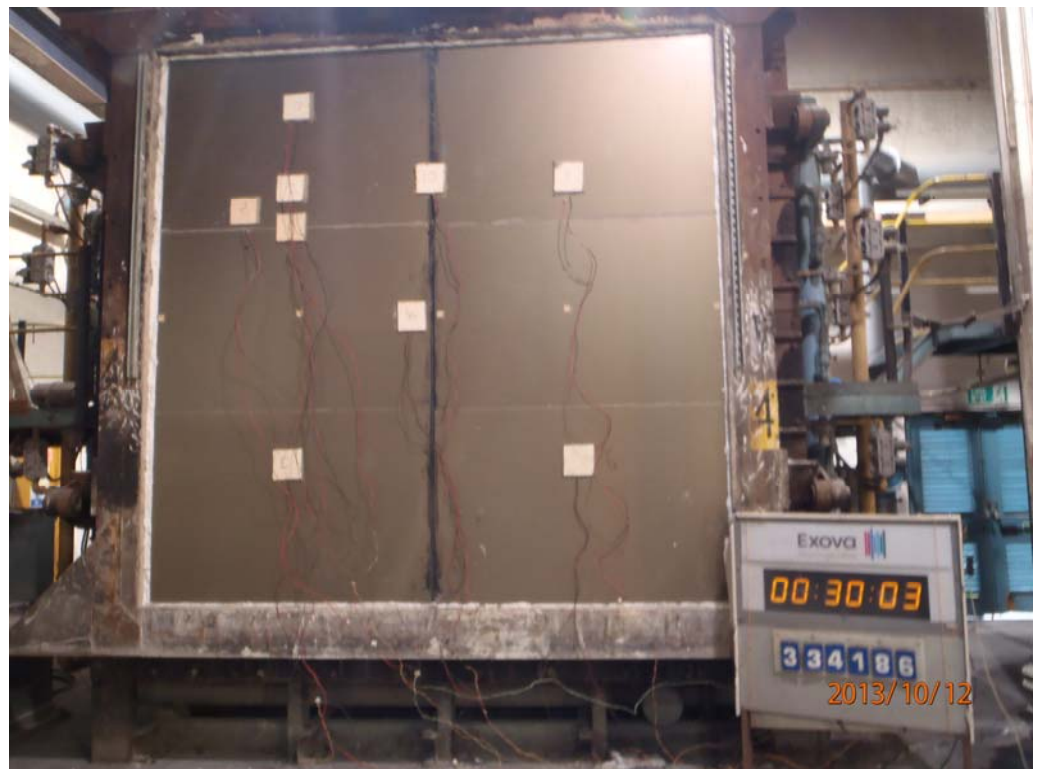
The unexposed face of the specimen after 30 minutes of testing

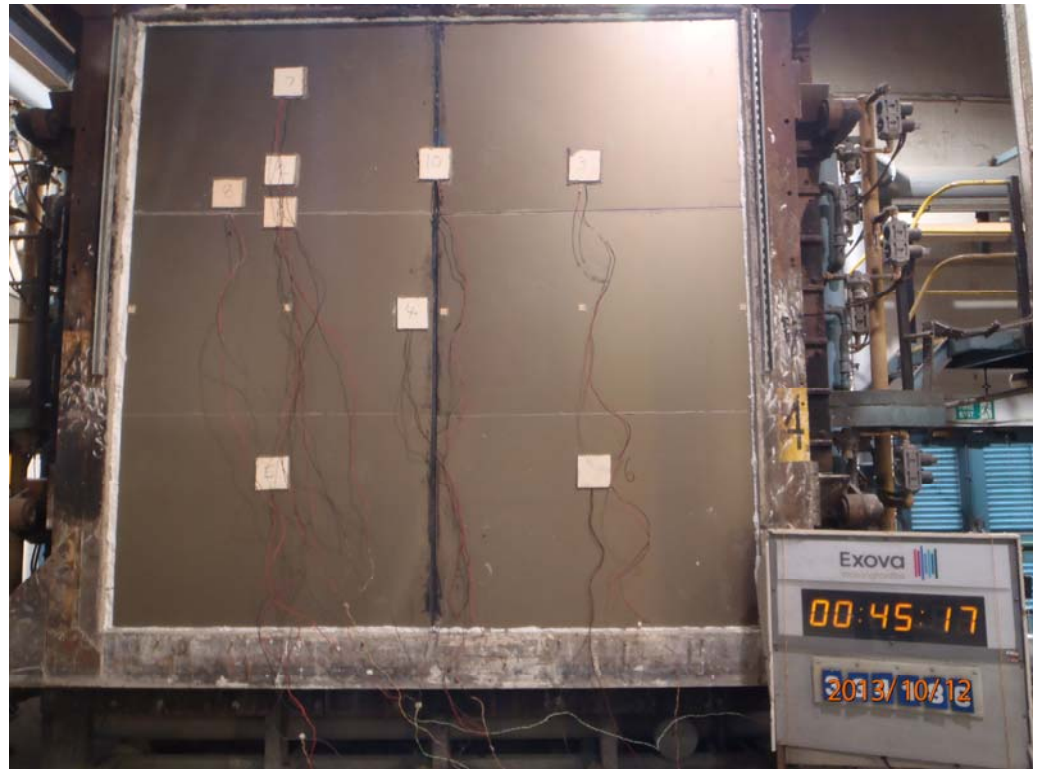
The unexposed face of the specimen after 45 minutes of testing

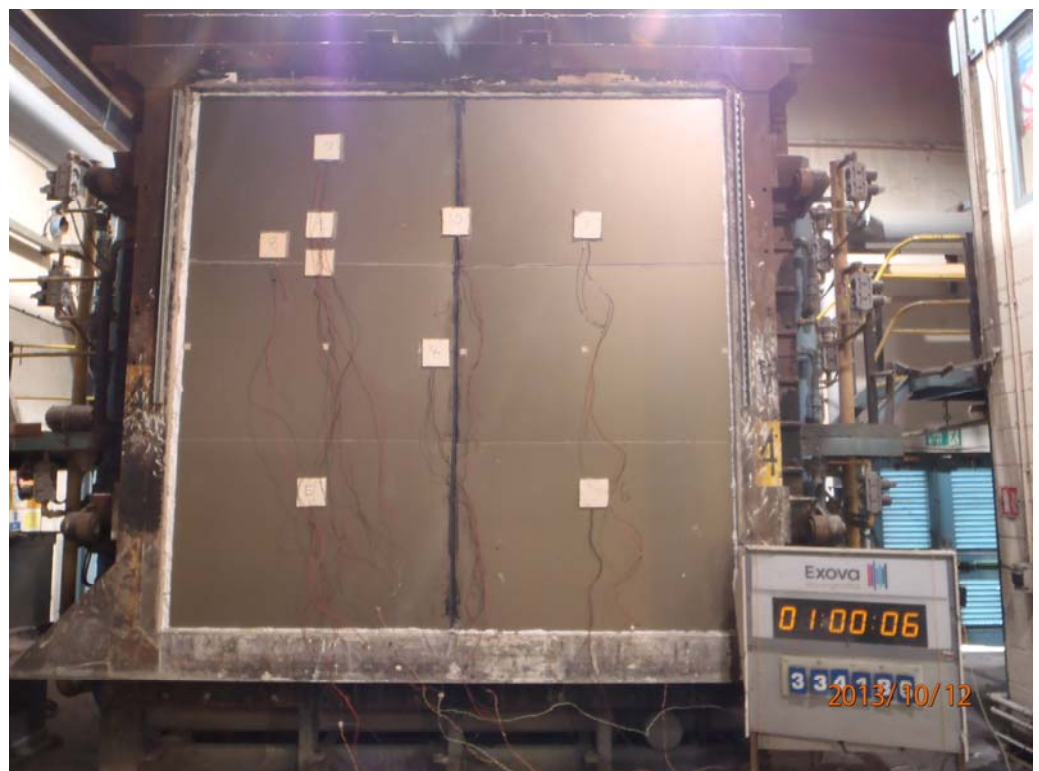
The unexposed face of the specimen after 60 minutes of testing

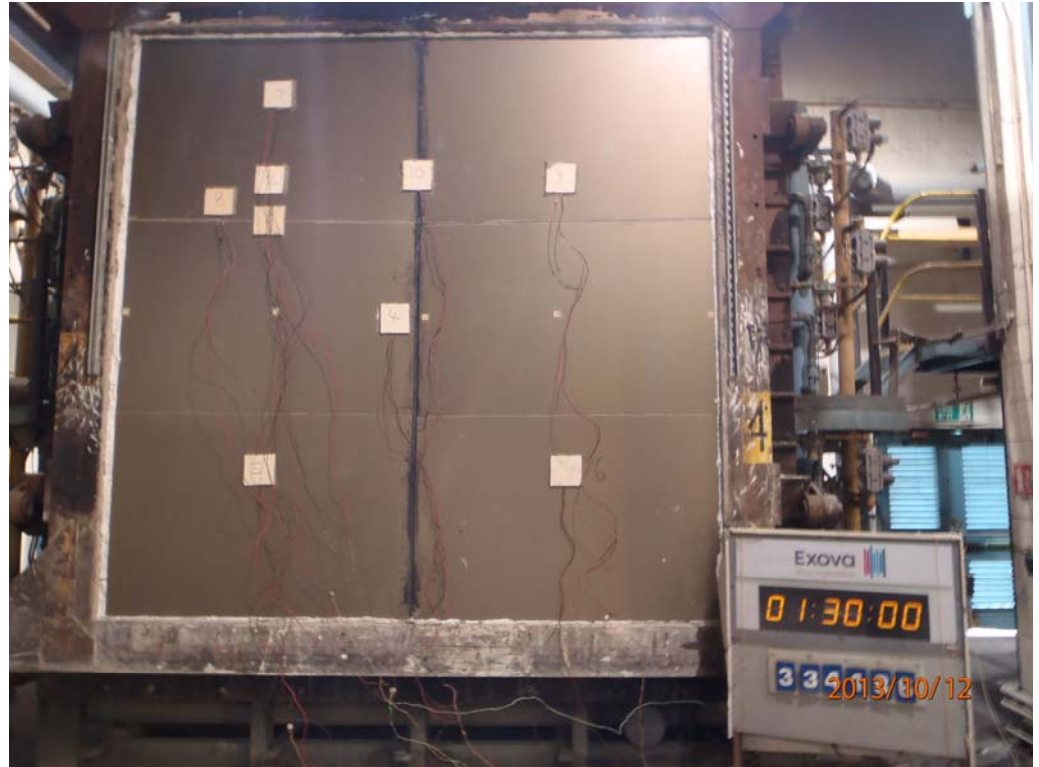
The unexposed face of the specimen after 90 minutes of testing

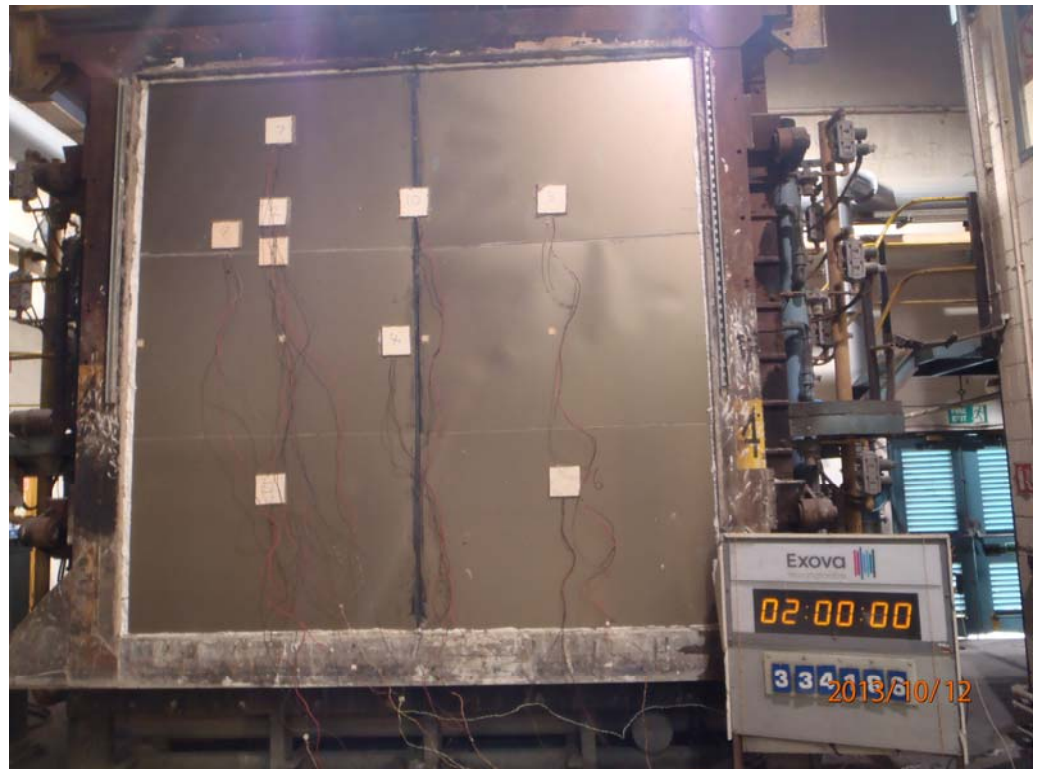
The unexposed face of the specimen after 120 minutes of testing

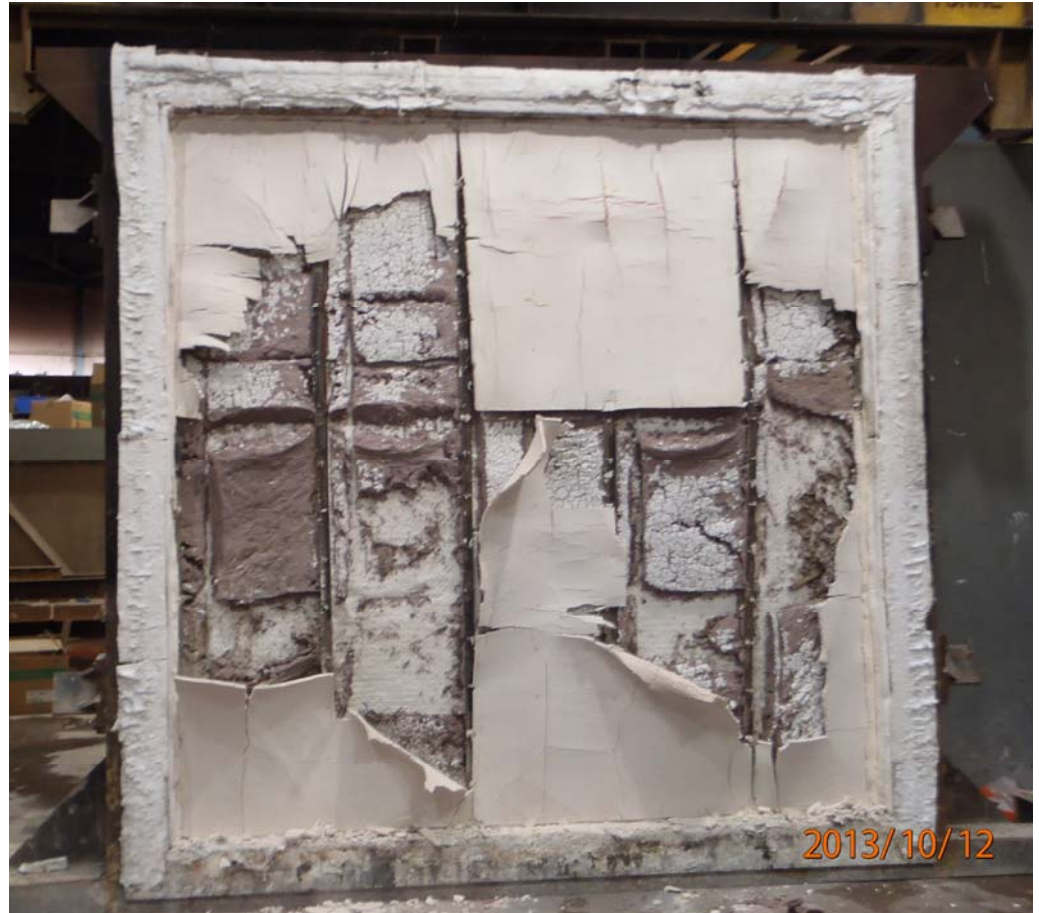
The exposed face of the specimen shortly after the test and just before the hose stream test

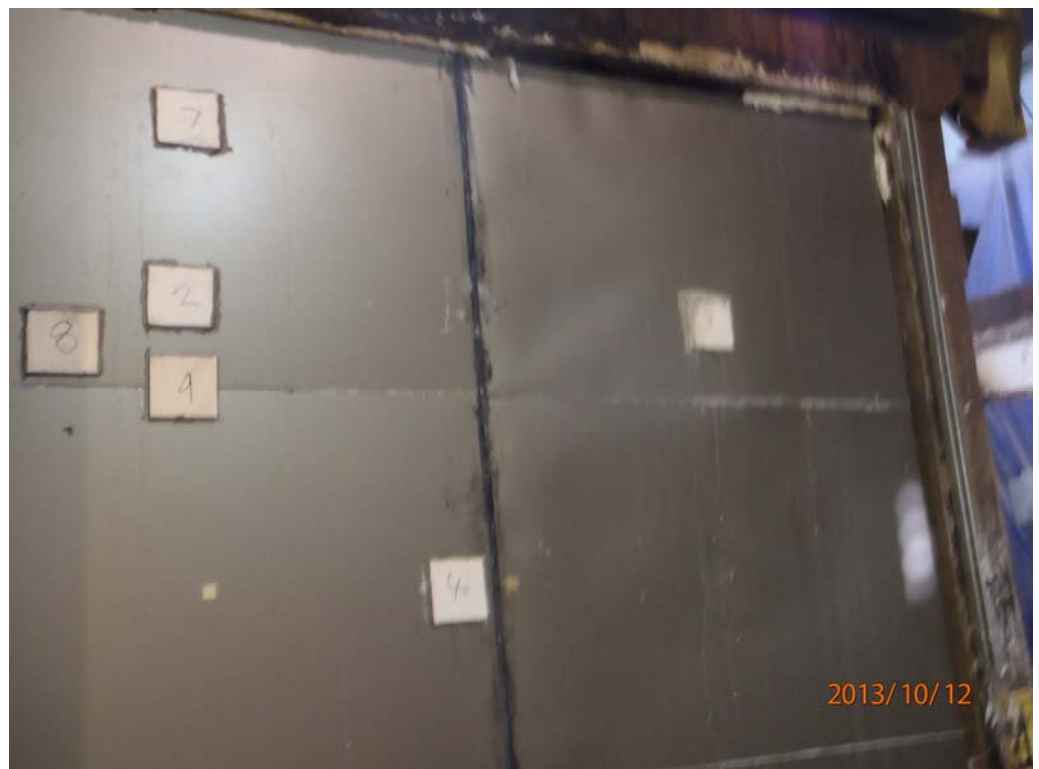
The unexposed face of the specimen during the hose stream test

00	00	Test started
00	15	Leakage of water from the right hand side top horizontal joint approximately 800 mm from the right edge. The water does not project from the surface of the specimen.
00	45	Leakage of water from the right hand side top horizontal joint approximately 800 mm from the right edge. The water does not project from the surface of the specimen.
01	00	Leakage of water from the left hand side top horizontal joint approximately 700 mm from the left edge. The water does not project from the surface of the specimen.
01	30	Again leakage from the top right hand side horizontal joint. The water does not project from the surface of the specimen.
02	00	Again leakage from the top at the left hand side top horizontal joint. The water does not project from the surface of the specimen.
02	30	Test Terminated.

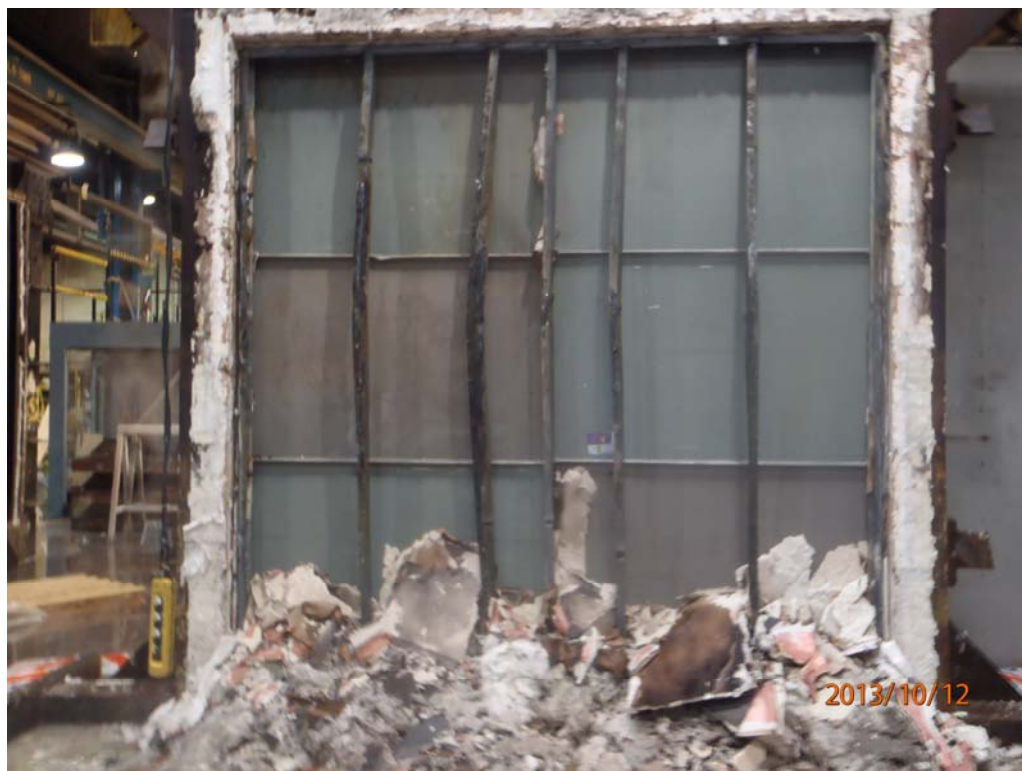
The exposed face
of the specimen
following the hose
stream test

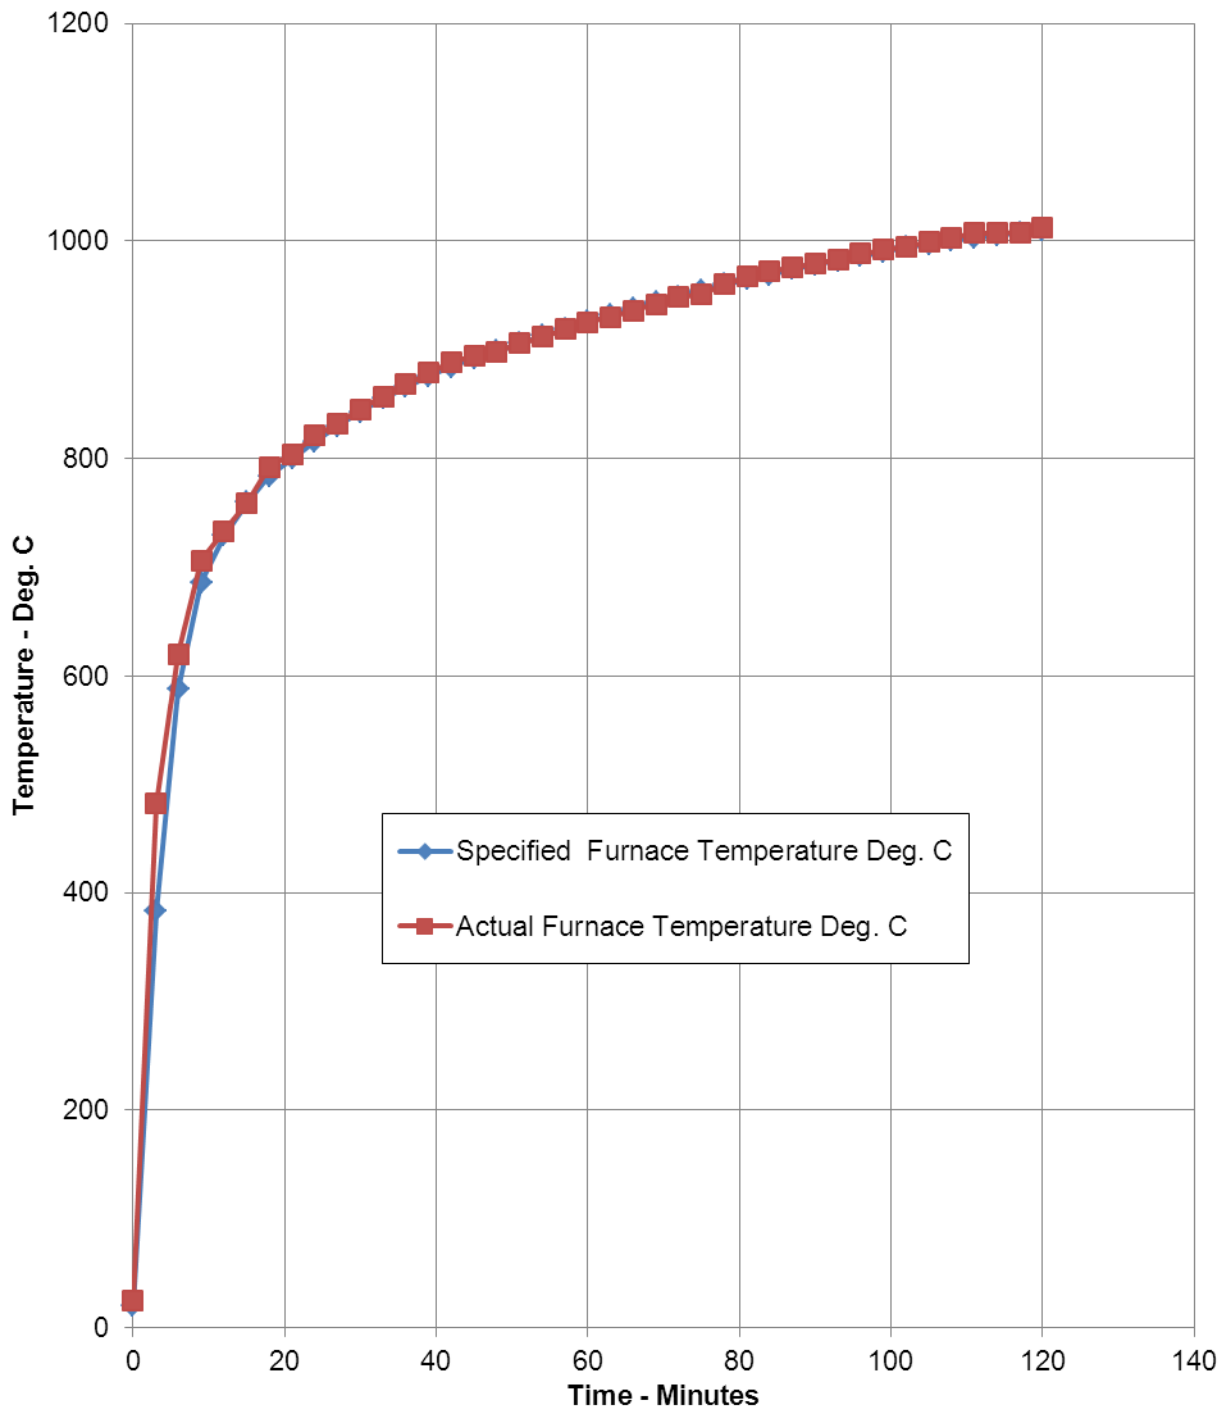
Graph Showing Mean Furnace Temperature, Together With The Temperature/Time Relationship Specified In The Standard

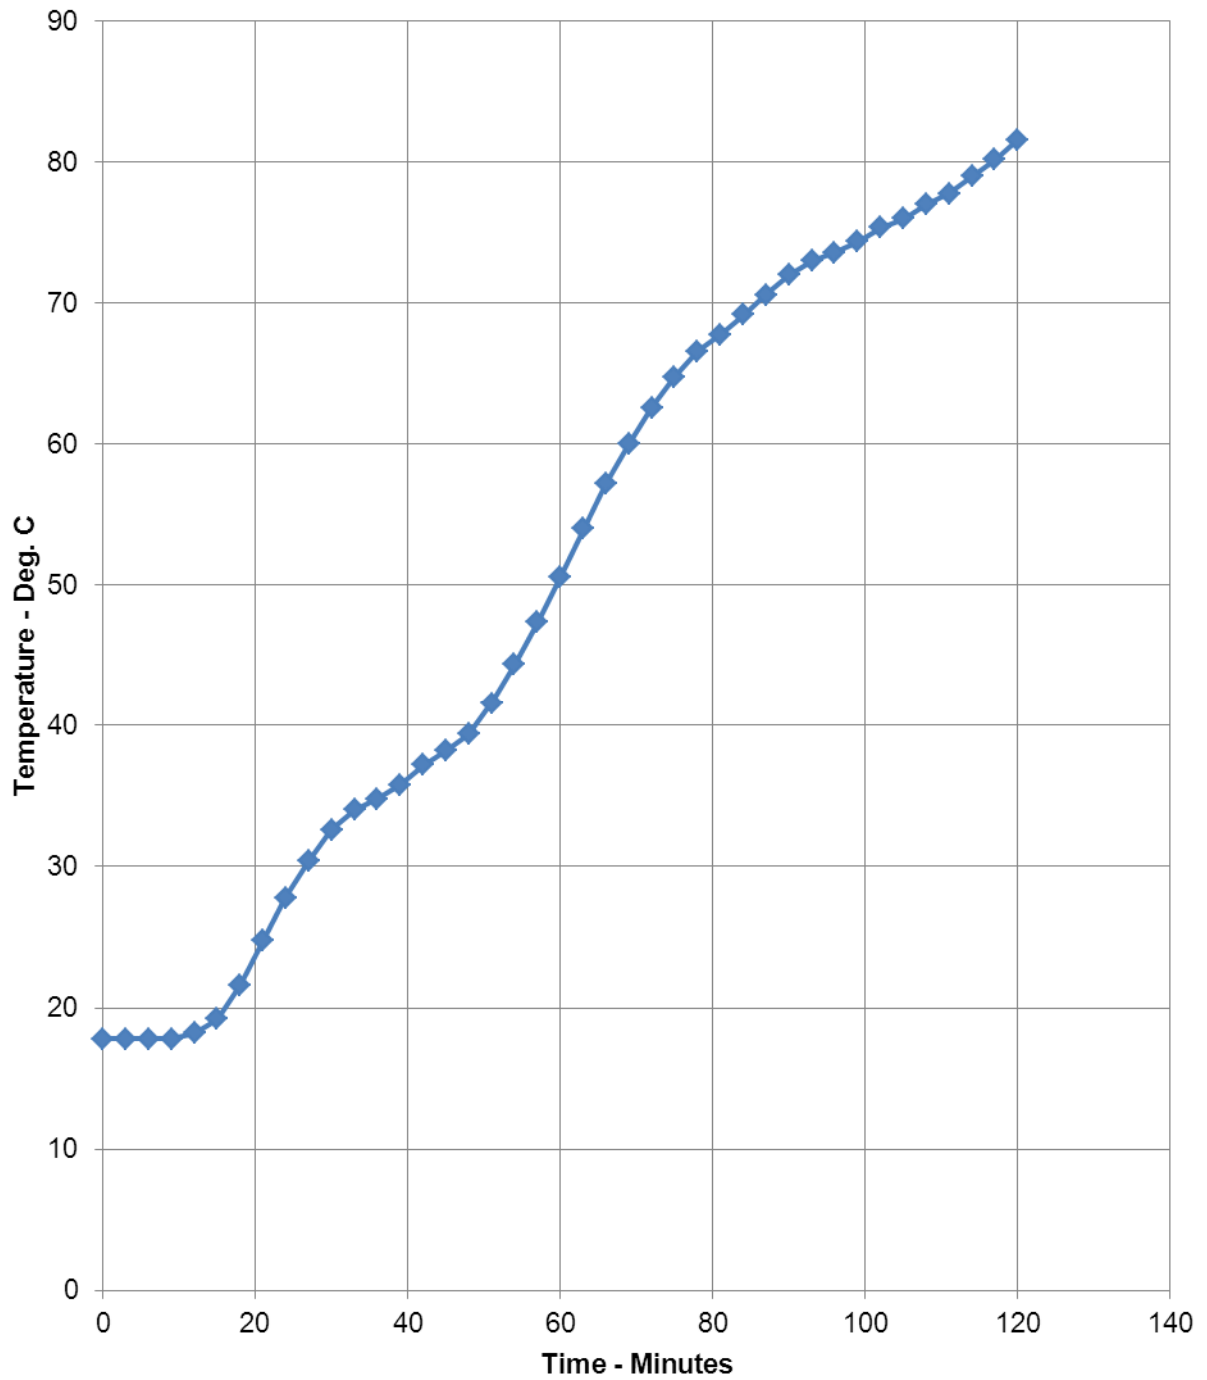
Graph Showing Mean Temperature Recorded On The Unexposed Surface Of The Test Specimen

Time Mins	T/C Number 7 Deg. C	T/C Number 8 Deg. C	T/C Number 9 Deg. C	T/C Number 10 Deg. C
0	19	20	20	20
3	19	20	20	20
6	19	20	20	20
9	19	20	20	20
12	19	20	20	20
15	20	21	20	21
18	22	22	22	23
21	25	25	24	26
24	30	27	27	30
27	34	30	30	33
30	37	32	32	36
33	39	34	34	38
36	41	36	35	40
39	42	37	36	42
42	43	38	37	43
45	44	40	38	45
48	46	41	40	47
51	48	43	41	50
54	51	46	44	53
57	54	49	46	56
60	58	52	50	60
63	61	56	53	63
66	65	59	56	66
69	67	62	59	69
72	69	65	62	71
75	71	67	64	74
78	72	69	66	75
81	74	71	68	77
84	74	72	69	78
87	75	74	70	79
90	76	75	71	80
93	76	75	72	81
96	77	76	73	83
99	77	77	74	84
102	78	78	75	85
105	78	79	75	87
108	78	80	76	89
111	78	80	77	92
114	79	81	78	94
117	80	82	78	98
120	80	83	79	101
